Lake Lemon Conservancy District

Aquatic Plant Management Plan 2000

Jill Hoffmann, LLCD Lake Biologist

January 2000

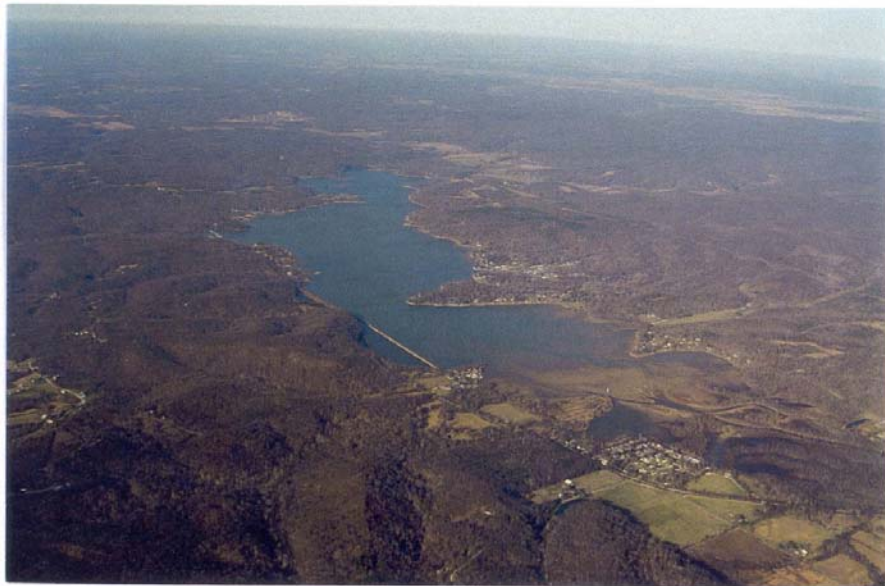
*Figure 1: Aerial Photograph of Lake Lemon during drawdown 1999
Note sedimentation in the east end*

In the fall of 1999 Lake Lemon experienced a notable decline in the density and distribution of *E. milfoil*. Such a decline is unusual for an exotic, prolific species such as this one. For this reason, LLCD is interested in monitoring *E. milfoil* and other macrophyte growth over time. Explanations for this decline are speculative; however, it is assumed that current management in regards to *E. milfoil* is proving moderately successful. This decline is pleasing but the decline is not necessarily a trend and therefore, *E. milfoil* should continue to be aggressively managed in the future.

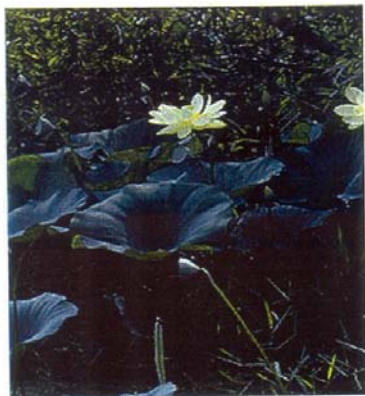
Figure 2: American Lotus in bloom

Lotus is known to be a sturdy plant that encroaches into shallow waters quickly. American Lotus is recognizable by its large, uncut circular leaves and large pale yellow flowers. Lotus flowers often grow to be 6-8 inches across and are composed of numerous petals. This large flower produces a sturdy seedpod in late summer. (See Figures 2 & 3). While American Lotus does flower and reproduce by seed dispersal, it also propagates by underground horizontal stems called rhizomes (See Figure 4). Knowing the plant's methods of reproduction is important when selecting a control method for Lotus. As discussed later, chemical control is only valuable if it has an effect on all parts of the plant including the rhizomes; therefore, a contact herbicide will be unsuccessful.

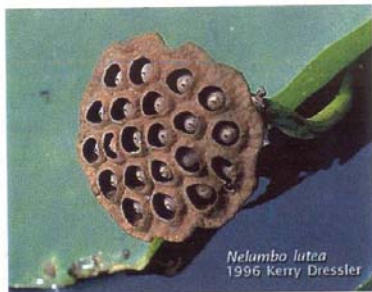
Figure 3: American Lotus Seed Pod

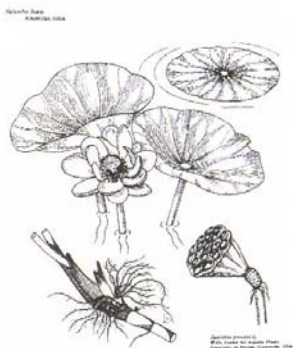
Figure 4: American Lotus leaves, flower, seed pod and root rhizomes

American Lotus is a perennial, aquatic, floating-leaved and/or emergent plant. Lotus is native to the United States. The preferred habitat of this plant is muddy shallow waters such as lake margins. The plant can grow to heights of between one and four feet. Upon reaching the surface of the water, American Lotus may remain as a floating-leaved plant or extend out of the water as an emergent plant. American Lotus can form large mats of dense vegetation that restrict a variety of recreational activities.

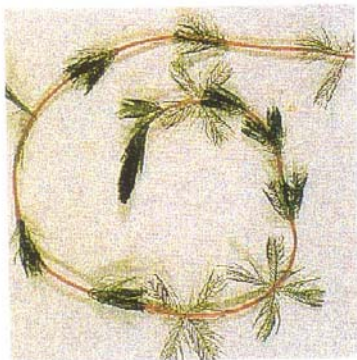
Figure 5: *E. milfoil* strand.
Note: whorled leaves

E. milfoil is a long, slender plant with green leaves in whorls of three or four with 12-16 pairs of thin leaflets. It is often described as feathery in appearance (See Figures 5 & 6). Recognizing the whorled leaves and the number of leaflets is critical to identifying E. milfoil from other native, less problematic milfoils. While E. milfoil will flower, it most often disperses via fragmentation. If detached, each floating node or fragment can become established if it comes in contact with mud. In addition to its preferred aquatic habitat, E. milfoil has been known to grow terrestrially on soil that is frequently washed with water. Knowing the plant's method of dispersal is vital when selecting a control method for E. milfoil. As discussed later, control methods that require disposal of E. milfoil biomass need to take into consideration the plant's dispersal methods.

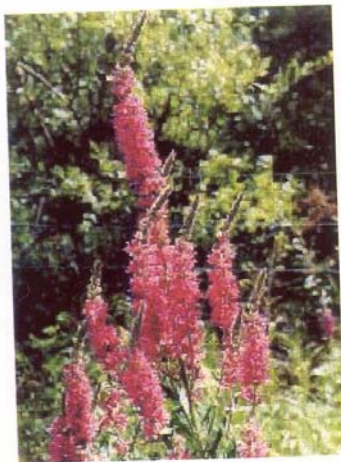
Figure 7: Purple loosestrife in bloom.

Purple loosestrife is a herbaceous emergent, perennial, recognized by long spikes of purple flowers (See Figure 7). Purple loosestrife can be found in wet meadows, shores, and in disturbed natural wetland areas (Hotchkiss, 1972). Like *E. milfoil*, purple loosestrife is an exotic species. As such it often out competes native wetland plants and impacts the wildlife that are dependent on the diversity of wetland plants for food. Purple loosestrife first appeared in the United States in the early 1800s but it was not widely spread until inland canals were constructed in the late 1800s (Malecki et al., 1993). Purple loosestrife first appeared in the Lake Lemon proper in the summer of 1999. (Its location is documented in Figure A of the appendix).

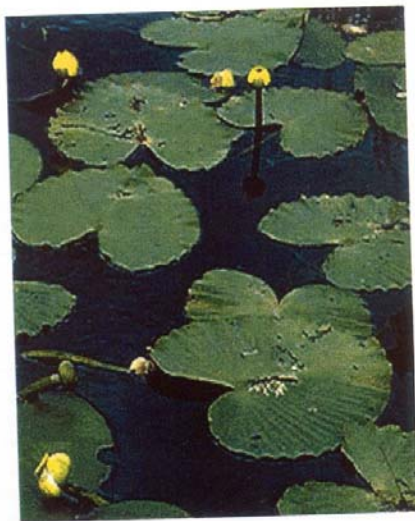
Figure 8: Spatterdock (Nuphar lutea) in bloom

Spatterdock is a rooted, floating-leafed plant similar to true water lilies (*Nymphaea species*). Leaves can be submersed, floating, or emergent above the water's surface. The leaves are heart-shaped and slightly longer than they are wide (See Figure 8). Spatterdock reproduces in two ways similar to American Lotus: by seed germination and by underground rhizomes or "runners." The flower is bright yellow with a single row of petals. The preferred habitat of this plant is shallow water but it may intrude into deeper water. Spatterdock, like Lotus, has substantial biomass and quickly impairs boating, swimming and fishing activities.

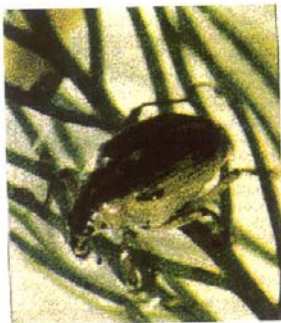
Figure 9: Milfoil weevil, *Euhrychiopsis lecontei*

Often biological control for exotic species such as *E. milfoil* requires the introduction of another exotic into the aquatic community. However, recent research has lead to an exciting discovery of a **native** biological control for *E. milfoil* known as the milfoil weevil, *Euhrychiopsis lecontei*. The milfoil weevil has been collected from lakes in the Eastern and Midwestern United States and is now being cultivated in laboratory settings. The weevil is small (~2-3 mm.) in size and reproduces by laying eggs on the growing tips of milfoil (See Figure 9). As the eggs hatch, the larvae begin to feed upon the plant. The larvae form pupae in the lower stem of the plant, adults hatch out, swim to the top of the plants and begin the life cycle again. In the Midwest, the weevil goes through about three generations in a summer (EnviroScience, Inc.). Over the winter, weevils move into the leaf litter around the lake margins and return to the water and milfoil the following spring.

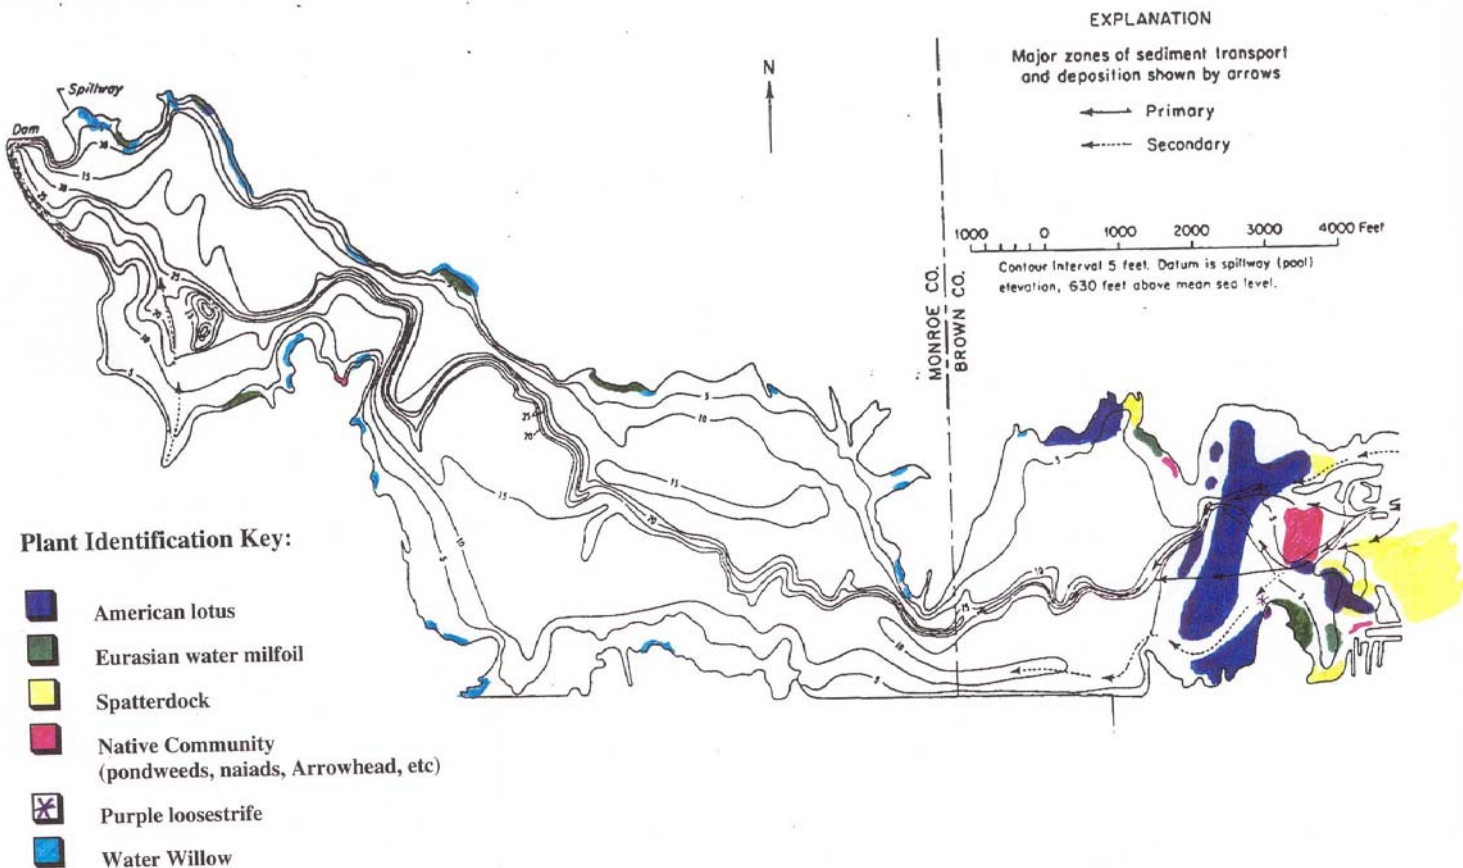
Figure A: Composition and distribution of Lake Lemon's aquatic vegetation in 1999

Spatterdock has been encroaching into the east end of Lake Lemon and is presenting a recreational problem for residents of the Chitwood Addition. (See Figures A and B of the appendix for locations). Spatterdock has not presented a management problem in years past however; Spatterdock's recent spread has raised concern among residents for lake access and the reduced fishing opportunities resulting from its growth. While Spatterdock is a native plant, it still warrants future control in order to accommodate all lake users.

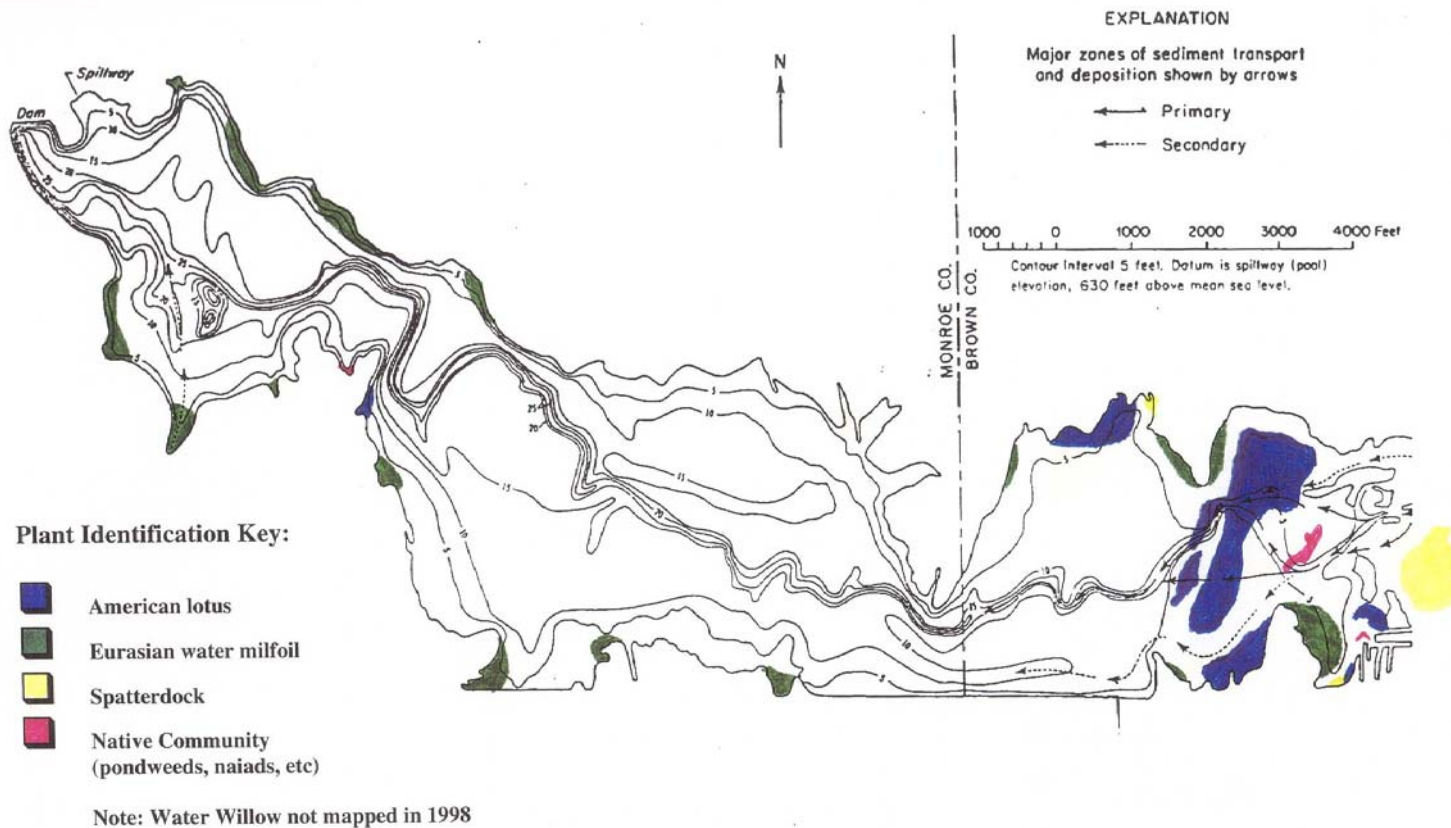
Figure B: Composition and distribution of Lake Lemon's aquatic vegetation in 1998

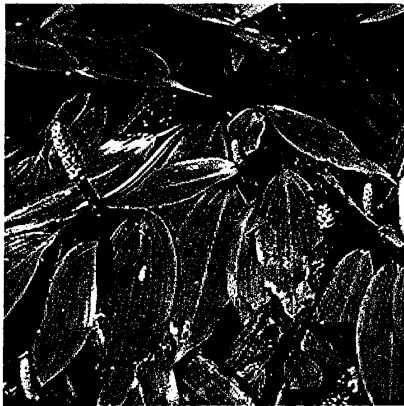
Pondweed (Photo from University of Florida,
Center for Aquatic and Invasive Plants)

American pondweed is a submersed plant with elliptical shaped floating leaves and lance shaped submerged leaves. The leaves are between 5 to 20 centimeters long with the submerged leaves noticeably smaller than the floating leaves. American pondweed produce green flowers on one to three inch emerged spikes. American pondweed flourishes in soft sediment or substrate and can grow in water up to fifteen feet deep.

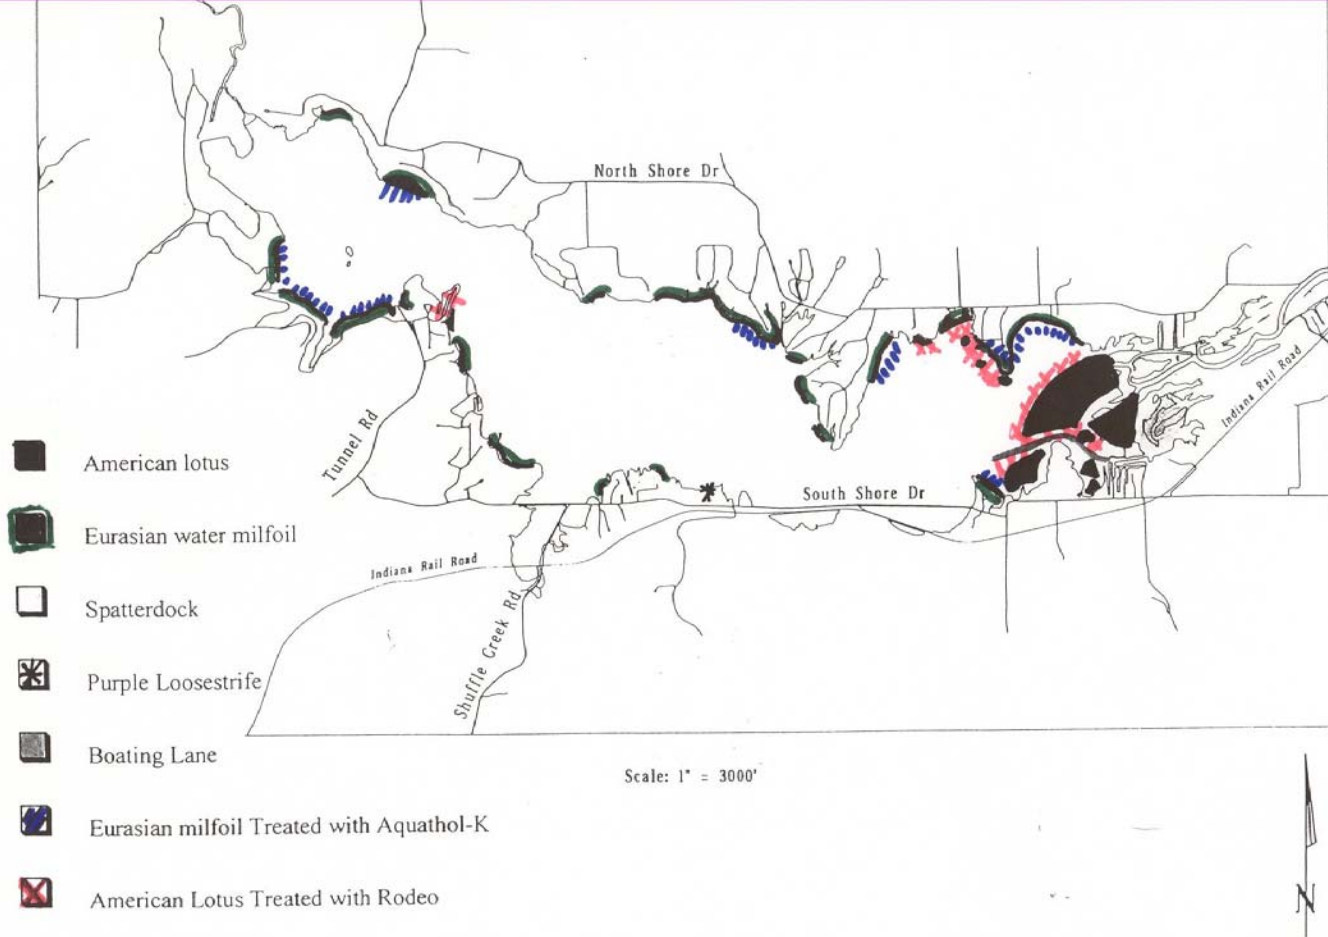
Figure A: Vegetation Distribution and Treatment in 2000

The cool, rainy spring and early summer resulted in a late but substantial crop of American Lotus. Similar to previous years, the growth was primarily concentrated in the eastern end of the lake. However, small patches of plants were observed in many areas including areas directly east of Point Idalawn and in a cove east of Riddle Point Park (See Figure A for growth distribution).

Several (10-15) plants of Purple Loosestrife were observed growing on a rocky point on the south shore of Lake Lemon on July 19th (See Figure A for mapped location). The plants were removed by cutting the seed heads and stems, taking care to avoid dispersing or transporting the seeds. The roots could not be effectively dug out due to the rocky terrain.

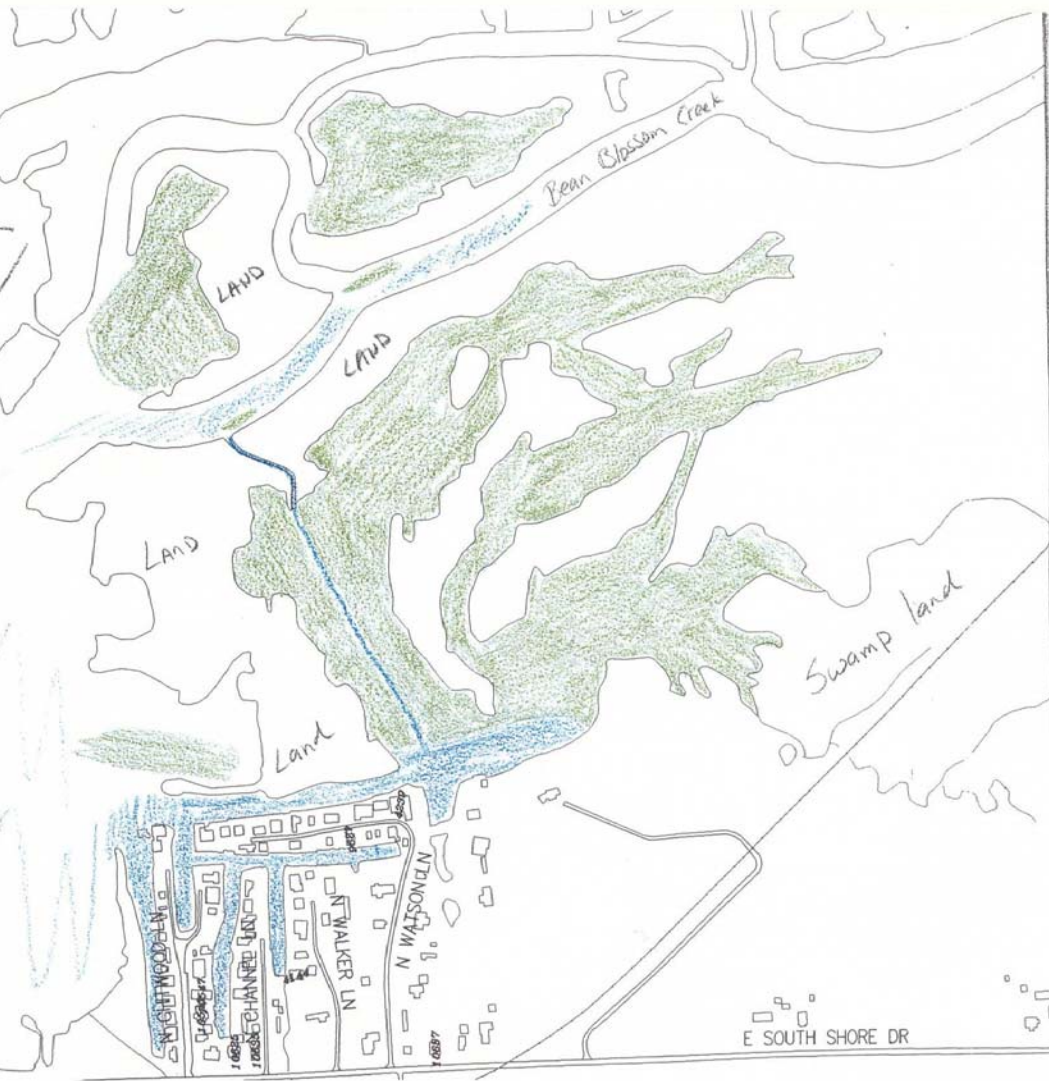
#3 Spatterdock Eradication Plan

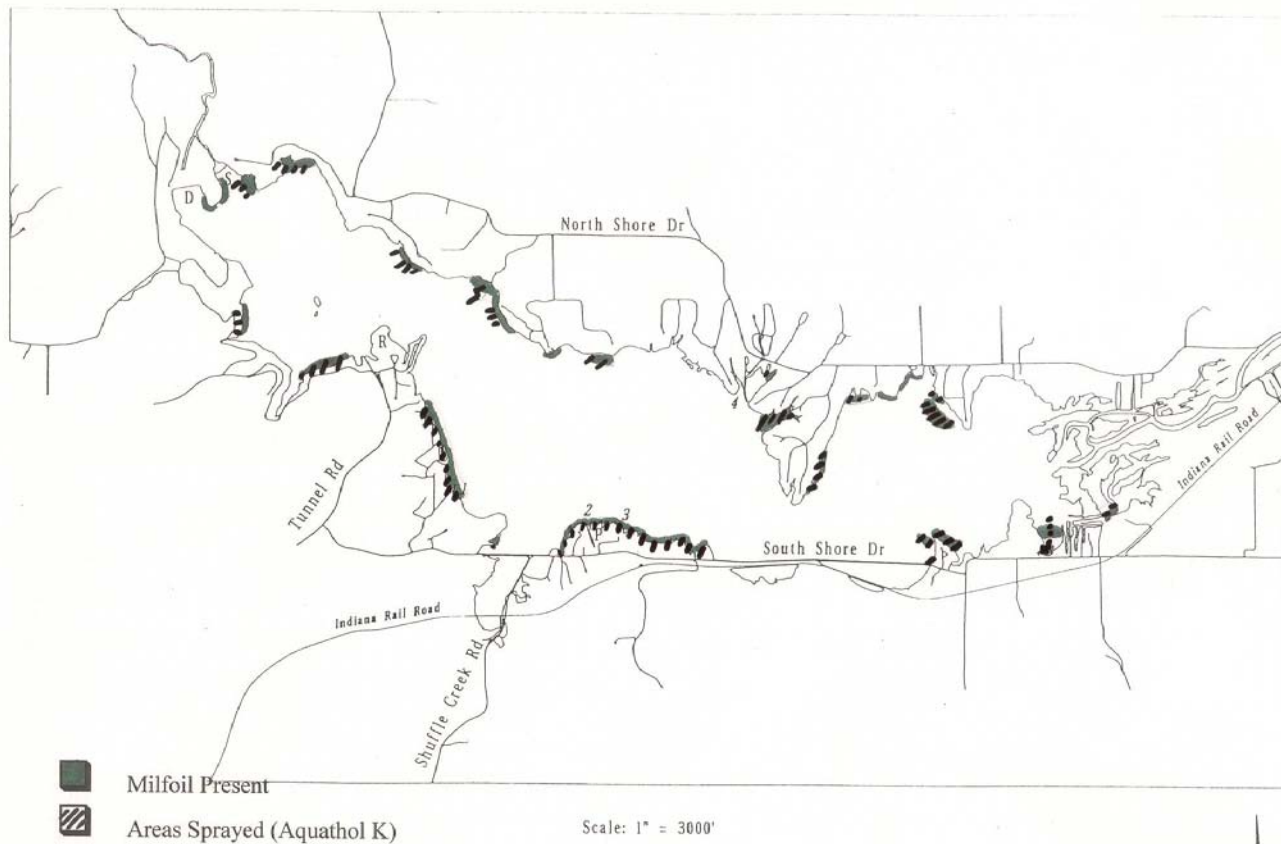
Figure C: Late Eurasian Water Milfoil (June – August)

The dry and hot early spring resulted in a dense Milfoil growth in early May. The lack of rain reduced the amount of sediment entering the lake from Beanblossom Creek. The water column was uncharacteristically clear. Secchi disk measurements exceeded 5 feet. Milfoil flourished even in deeper areas of the lake that usually do not report excessive growth (Figure B). Due to the excessive milfoil growth observed in Lake Lemon, LLCD requested a permit to chemically treat additional acres of milfoil. As the summer progressed, the transparency decreased and the growth of milfoil slowed (Figure C).

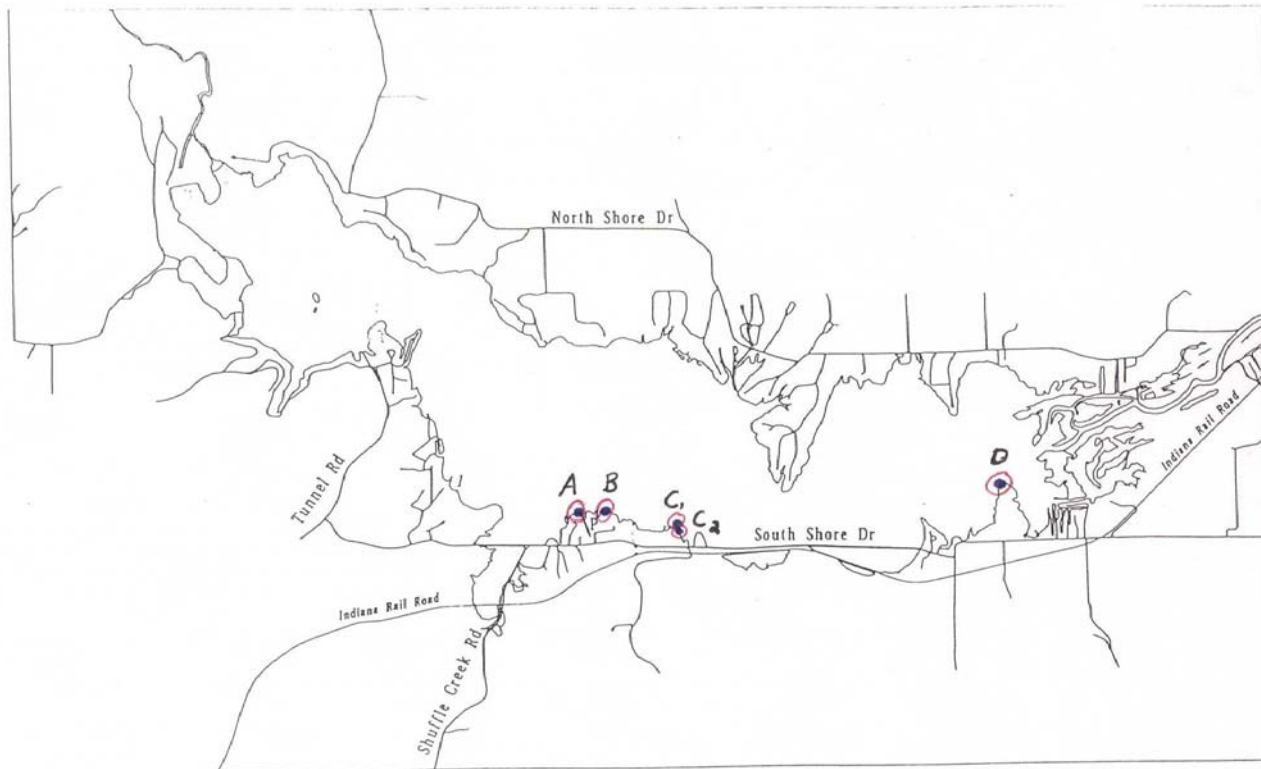
Figure D: Purple Loosestrife

● Areas with Purple Loosestrife

An ornamental planting of six plants of Purple Loosestrife was discovered in the yard of a lakeside residence in early July (Figure D). The plants were planted by a landscaping company, who claim the plants were sterile hybrids and not able to produce seeds. The purple loosestrife was planted before the ban on the sale and planting of purple loosestrife plants, including hybrids. The property owners were informed about the problems associated with Purple Loosestrife and agreed to remove the plants from their yard.

Approximately 60 plants of Purple Loosestrife were observed in three areas on Lake Lemon on July 12th (See Figure D for mapped location). Two plants were observed on Little Africa, the location of the first recorded Purple loosestrife plants on Lake Lemon in 1999 (mapped location D) and 15 to 20 plants were observed in the same area from which plants were removed in 2000 (mapped location C). An area without previous documentation of Purple loosestrife had dense growth of approximately 40 small, young plants (mapped location B). All plants were removed first cutting the flowers and seed heads taking care to avoid dispersing or transporting the seeds. In the areas with less dense growth the entire plant including the roots were removed. The one area with the densest growth of plants was sprayed with Round-Up taking care to avoid contamination of the nearby lake water.

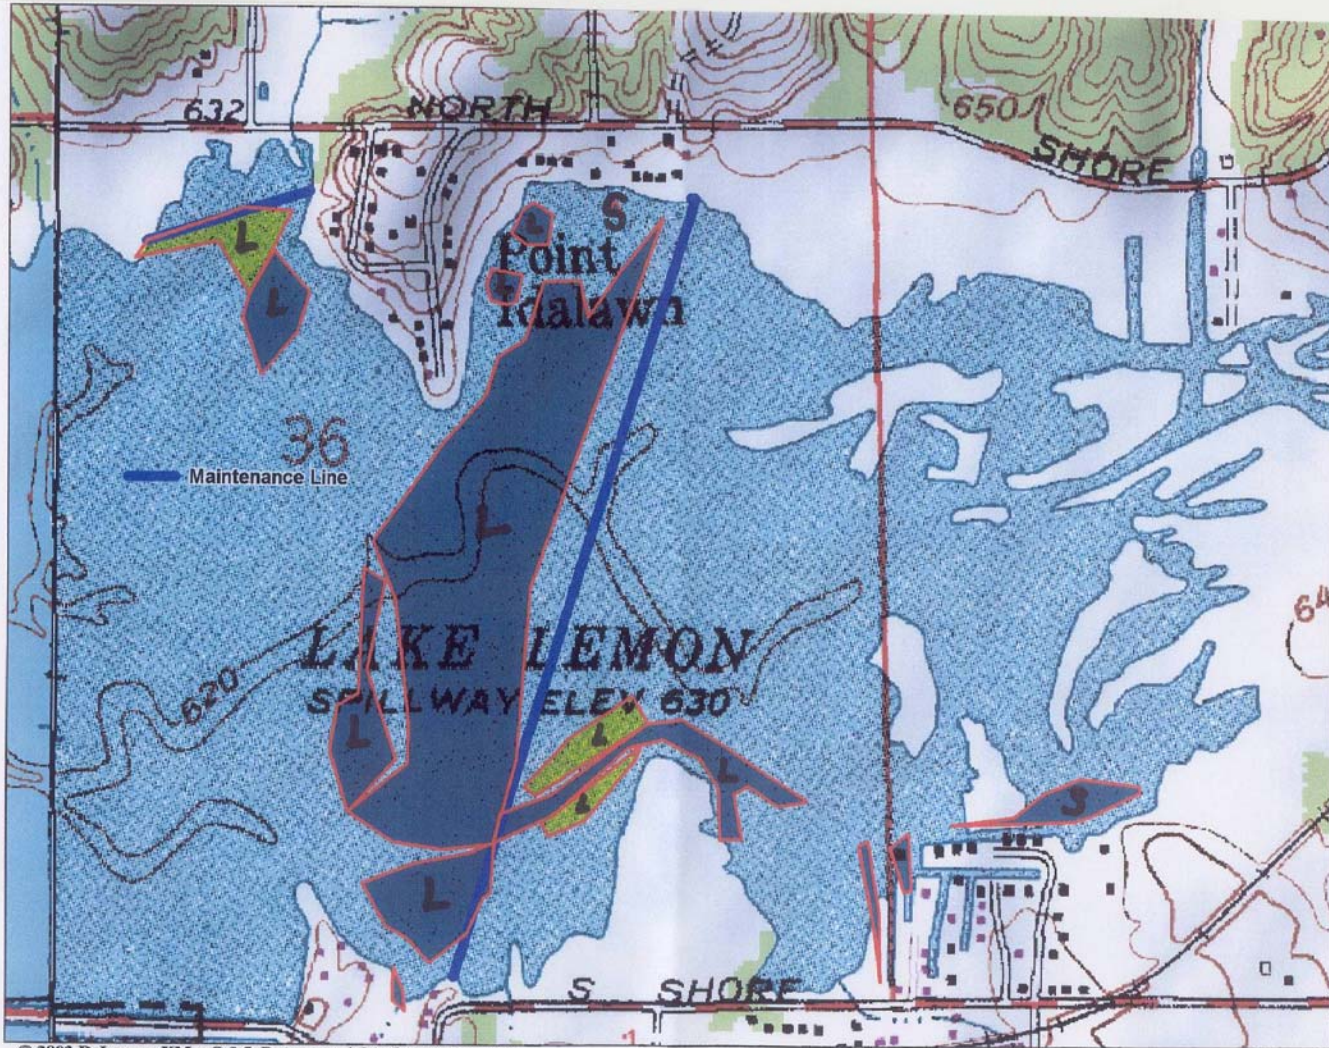
Figure 1: Lotus (L) and Spatterdock (S) Treated

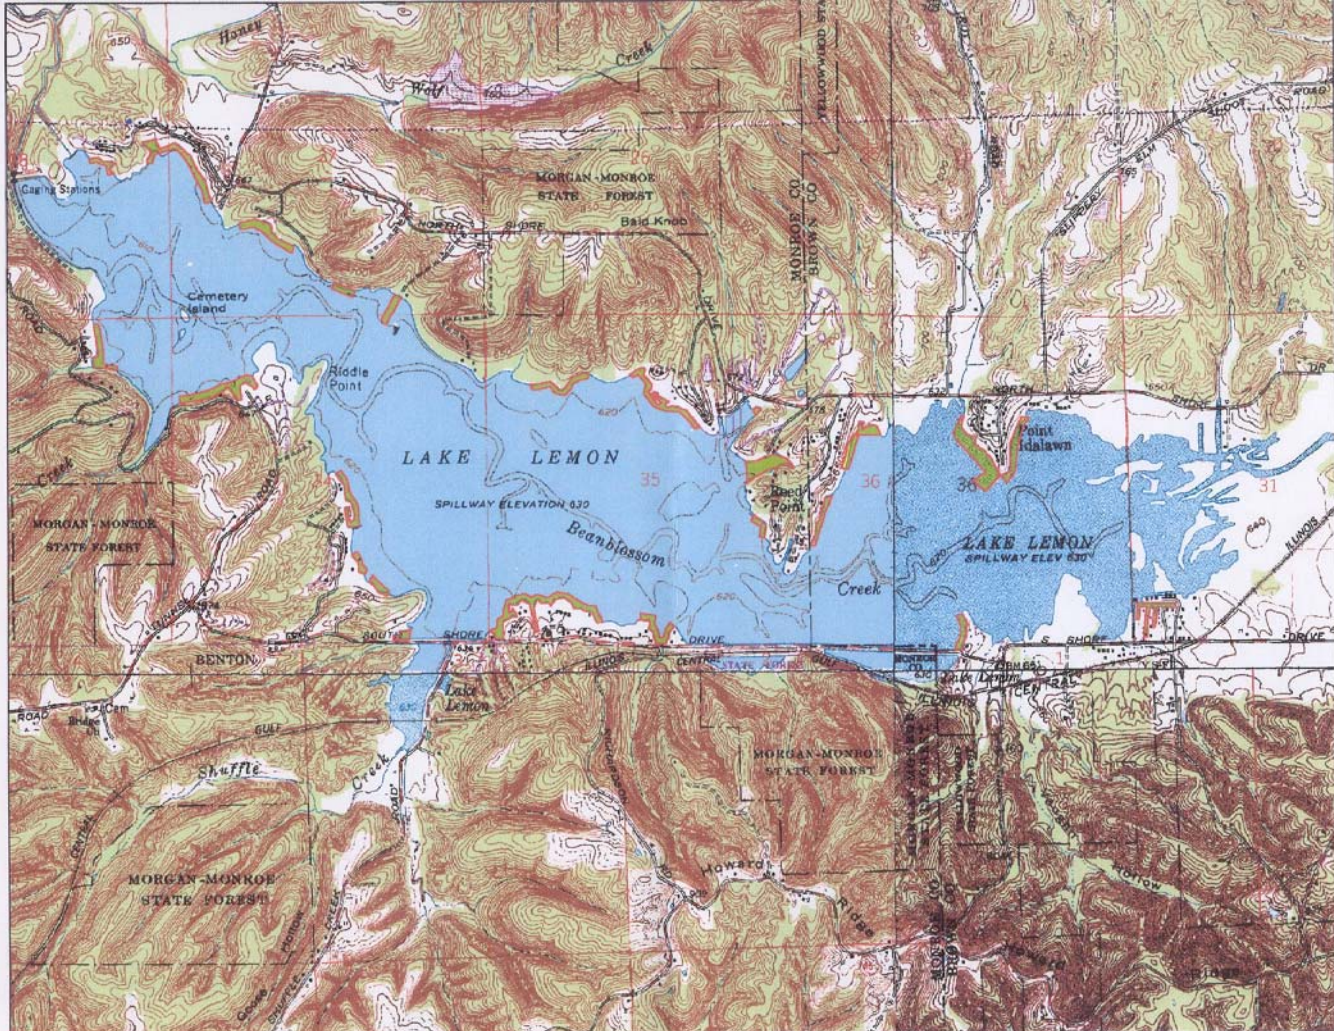
Figure 4: Eurasian Watermilfoil Treated

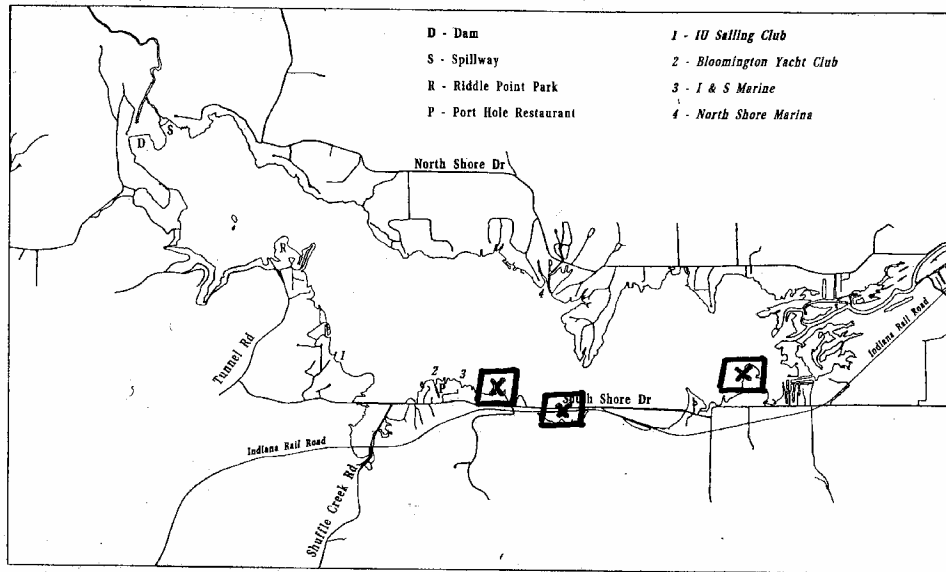
Lake Lemon Conservancy District
Figure 5: Purple Loosestrife Removed

Approximately sixty purple loosestrife plants were observed in three areas on Lake Lemon this season (see Figure 5). Thirty plants were observed on Little Africa, which is the location of the first recorded purple loosestrife plants on Lake Lemon. An additional five plants were found on a small point west of the long causeway by I & S Marine. These plants were removed on July 23rd by first cutting the flowers and seed heads, taking care to avoid dispersing or transporting the seeds, and digging up the roots to prevent future growth. Information provided by a freeholder advised LLCD of approximately twenty-five more plants in the middle of the long causeway. These plants were sprayed with a glyphosate-based chemical on September 12th. Close observation of these and other areas will continue in the spring and summer of 2003.

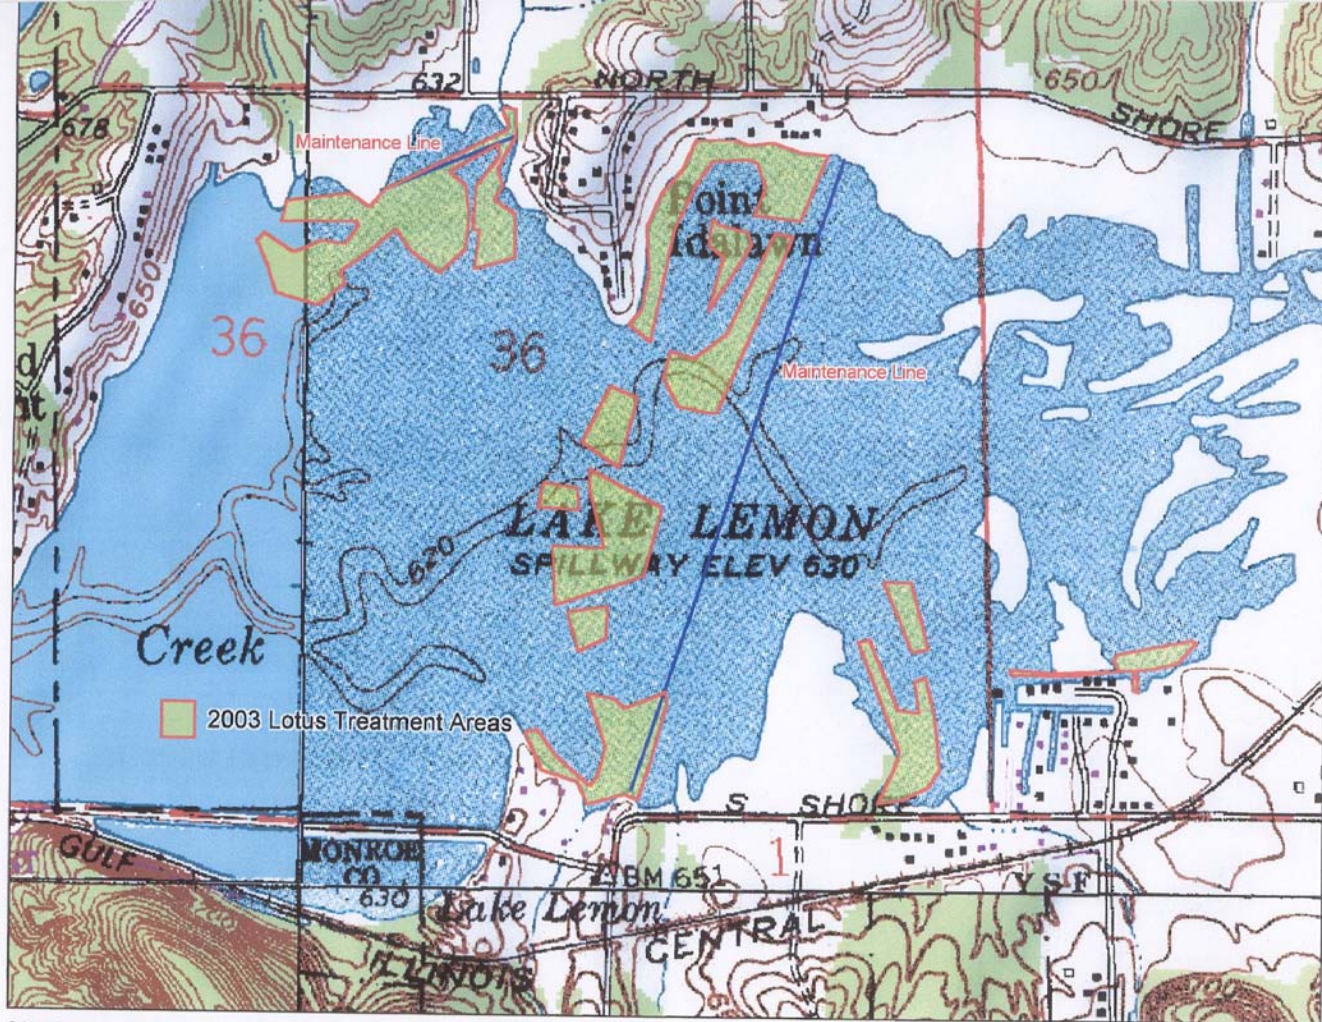
Figure 1: Lotus Treatment Areas

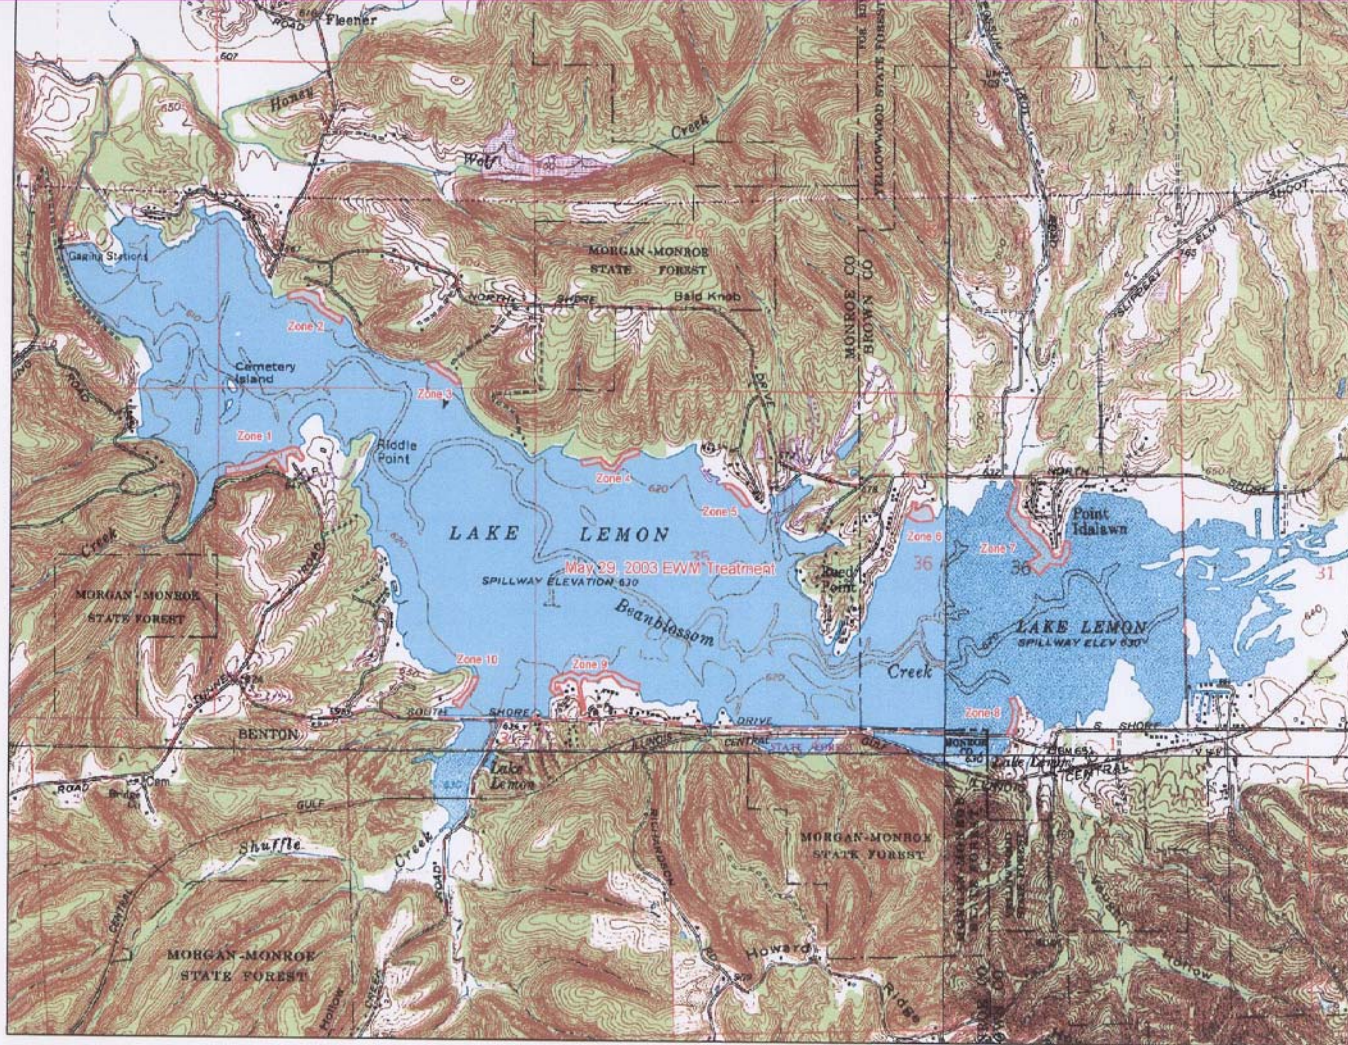
Figure 3a: Early Summer Milfoil Treatment

Due to the excessive milfoil growth observed in previous years, LLCD requested a permit to chemically treat 75 acres of milfoil. On May 30th, a total of thirty-four acres of milfoil were treated using Renovate 3. Forty-one acres of milfoil were treated on July 10th; and one and a half acres on August 28th also using the chemical Renovate 3 (see [Figures 3-zones & 3b](#)). The Conservancy District staff did not mechanically harvest any areas to control the presence of milfoil.

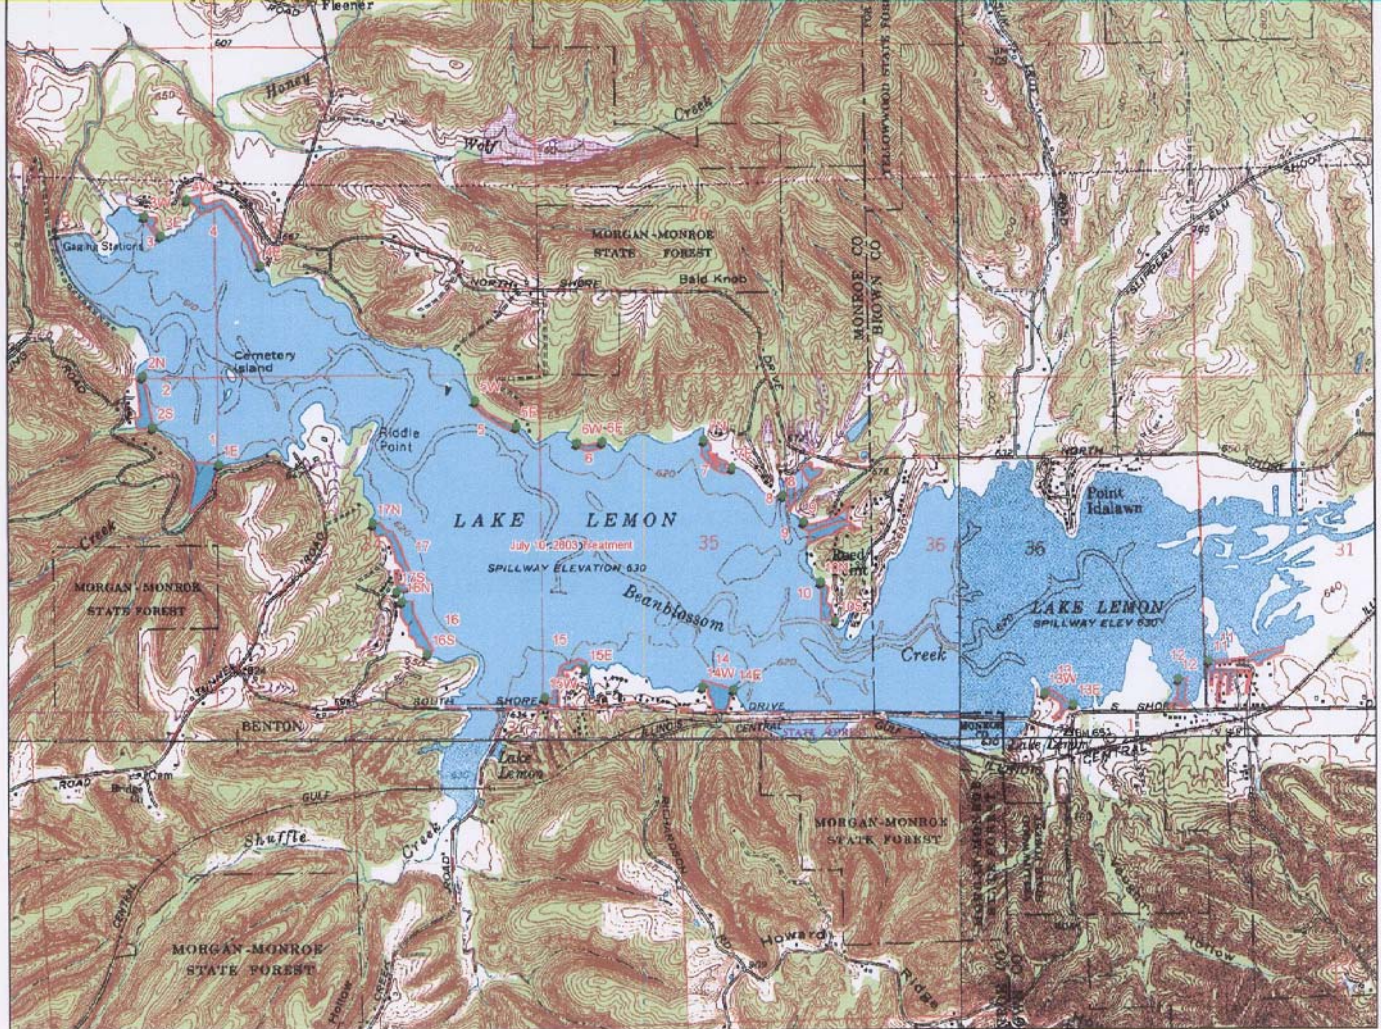
Figure 3b: Late Summer Milfoil Treatment

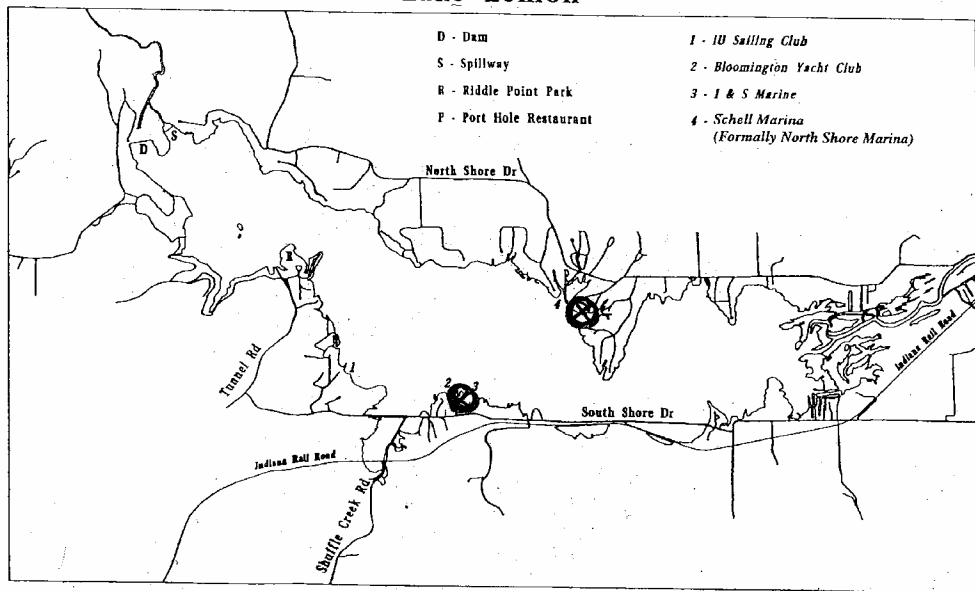
Figure 4: Purple Loosestrife Removed

Approximately twenty-five purple loosestrife plants were observed in two areas on Lake Lemon this season (see [Figure 4](#)). Twenty plants were observed growing on a resident's shoreline located along South Shore Drive. An additional five plants were found on residential shoreline east of Lake Lemon Marina. These plants were removed in June by first cutting the flowers and seed heads, taking care to avoid dispersing or transporting the seeds, and digging up the roots to prevent future growth. Close observation of these and other areas will continue in the spring and summer of 2004.
